Use of Guided Long Wave
Ultrasonic Inspection for Anomaly
Locating and Use of Composite
Repair Materials

12" x 10" M-2 Oil Pipeline

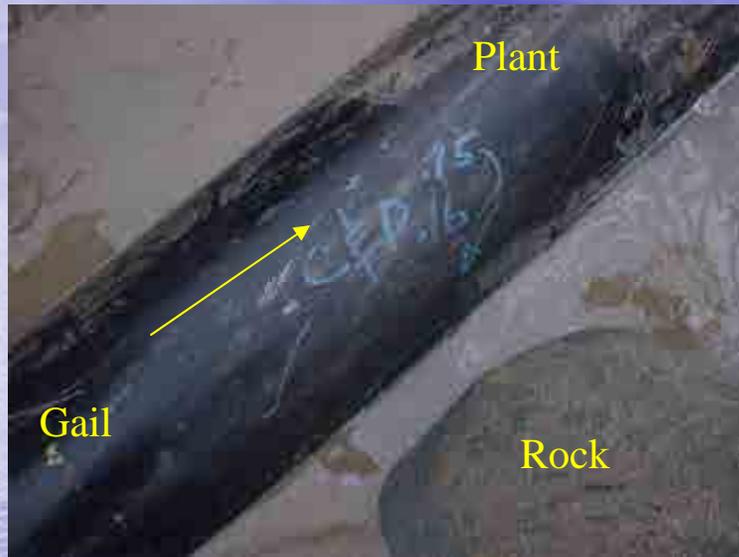
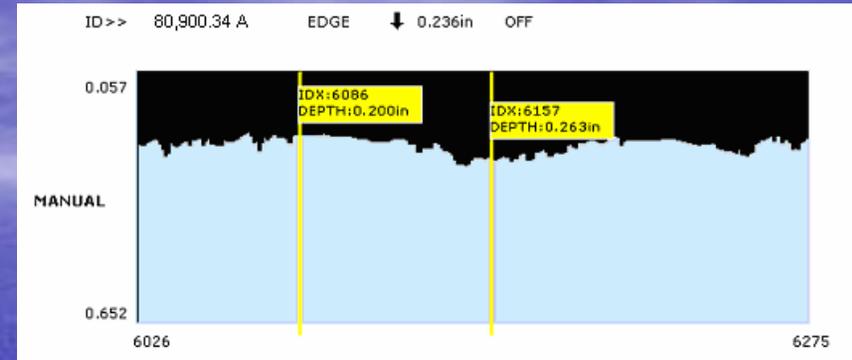
Scan – Feature 80,900.34

The remaining thickness in this area ranged from .200" to .263"

The top half of the piping was scanned to reveal a remaining thickness ranging from .200" to .263" from a nominal thickness of .375"
